BDN FASTENERS

TEST CERTIFICATES
3RD PARTY LABORATORIES

TEST CERTIFICATES SURFACE TREATMENT

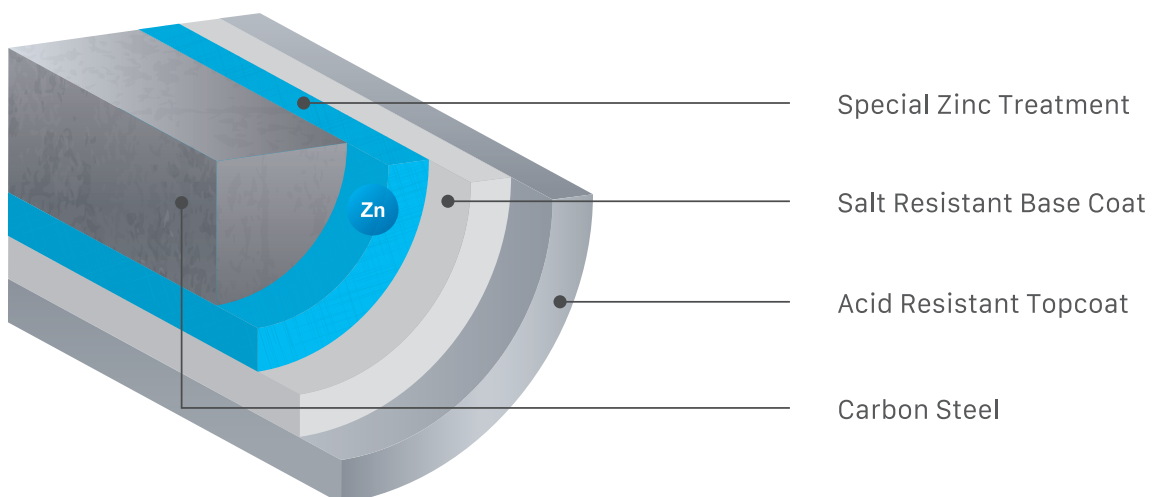
BDN® Ruspert Coating consists of multiple layers of specially formulated coatings that can easily withstand 1000hrs of salt spray test (AS 2331.3.1-2001) and 15 Kesternich cycles (DIN50018 2.0 SFW)

BDN® Ruspert Coating

Conventional Coating

Coating Thickness: 18-25um

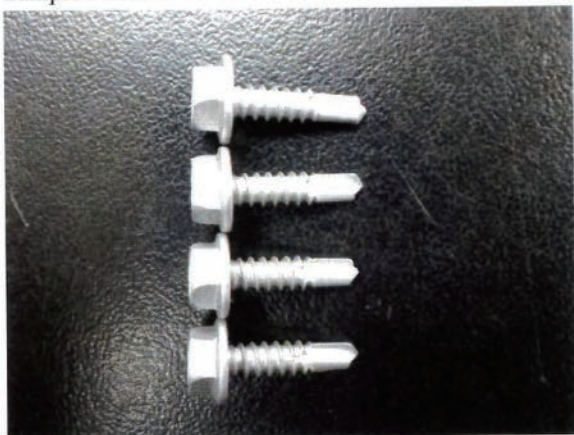
Fig. 1 : Received samples

No red rust was found on the head of all samples

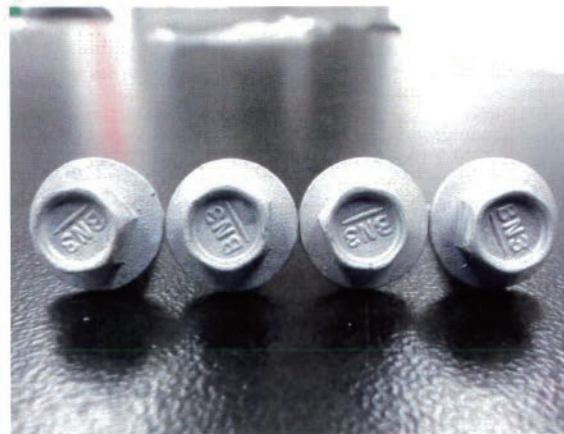
Fig. 3 : After test

No red rust was found on the head of all samples

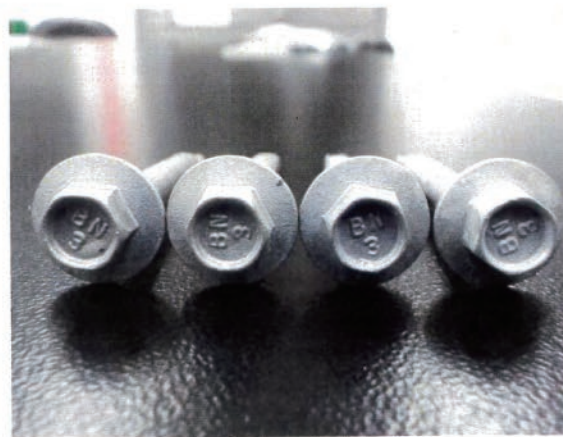
Fig. 3 : After test

No red rust was found on the head of all samples

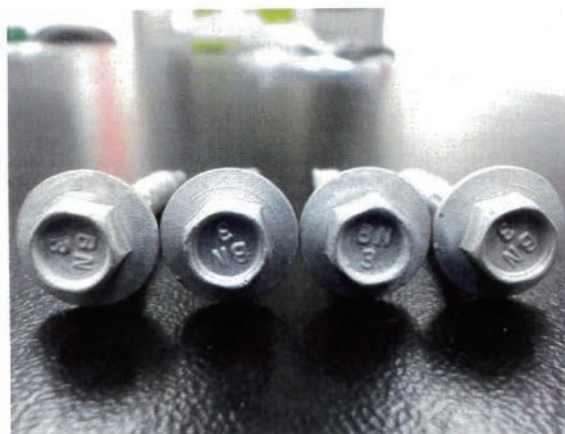
Fig. 3 : After test

No red rust was found on the head of all samples

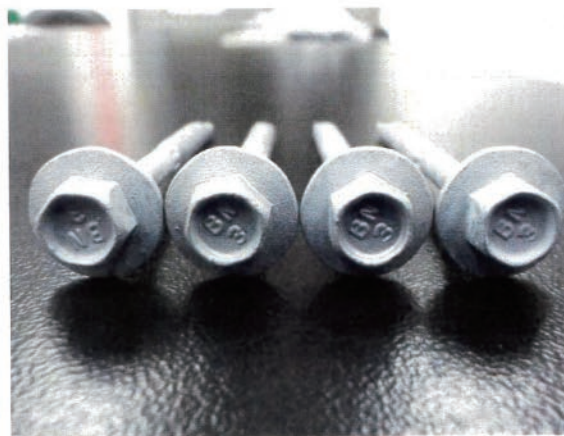
Fig. 3 : After test

No red rust was found on the head of all samples

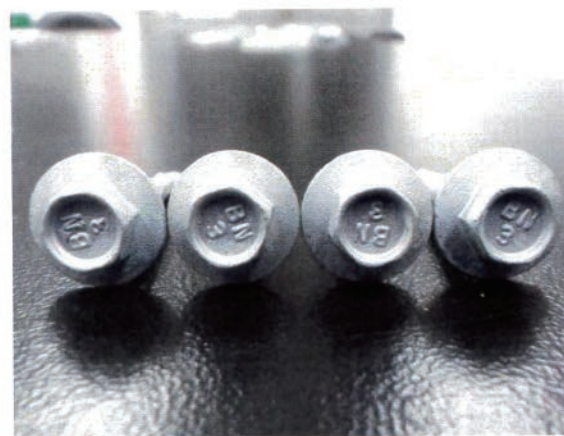
Fig. 3 : After test

No red rust was found on the head of all samples

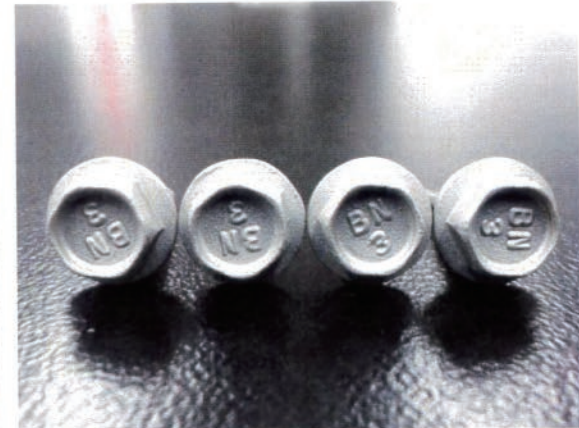
Fig. 4 : After test

No red rust was found on the head of all samples

Test Equipment		ERICHSEN 519/SA	
SO ₂ Concentration		2.0 L (0.67%) / Cycle	
Method of Supporting specimens		As show in Fig. 2	
Test Cycle	1st test phase	Test Time	8 Hours
		Test Temp.	40°C±3°C
		Test Humidity	Approximately 100%
	2nd test phase	Test Times	16 Hours
		Test Temp.	18°C~28°C
		Test Humidity	75% max.

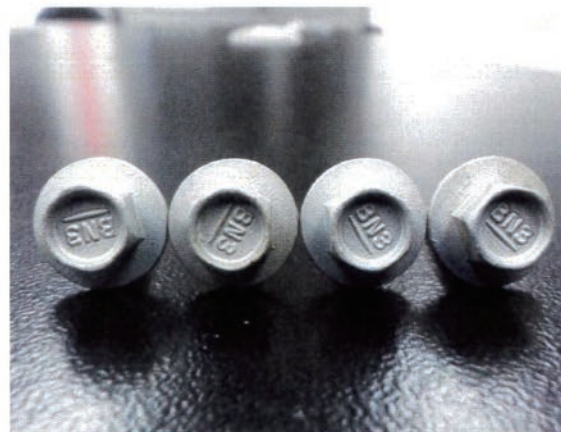
Fig. 4 : After test

No red rust was found on the head of all samples

Test Equipment		ERICHSEN 519/SA	
SO ₂ Concentration		2.0 L (0.67%) / Cycle	
Method of Supporting specimens		As show in Fig. 2	
Test Cycle	1st test phase	Test Time	8 Hours
		Test Temp.	40°C±3°C
		Test Humidity	Approximately 100%
	2nd test phase	Test Times	16 Hours
		Test Temp.	18°C~28°C
		Test Humidity	75% max.

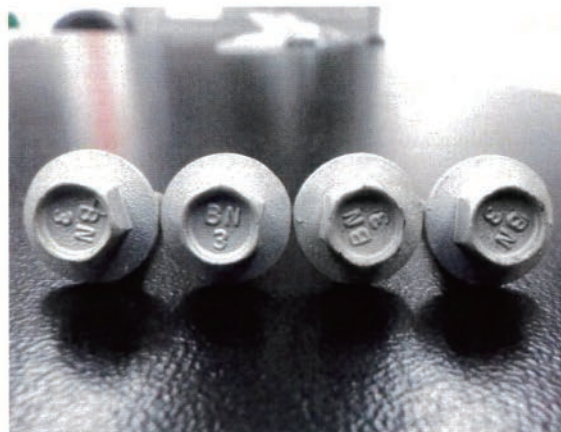
Fig. 4 : After test

No red rust was found on the head of all samples

Test Equipment		ERICHSEN 519/SA	
SO ₂ Concentration		2.0 L (0.67%) / Cycle	
Method of Supporting specimens		As show in Fig. 2	
Test Cycle	1st test phase	Test Time	8 Hours
		Test Temp.	40°C±3°C
		Test Humidity	Approximately 100%
	2nd test phase	Test Times	16 Hours
		Test Temp.	18°C~28°C
		Test Humidity	75% max.

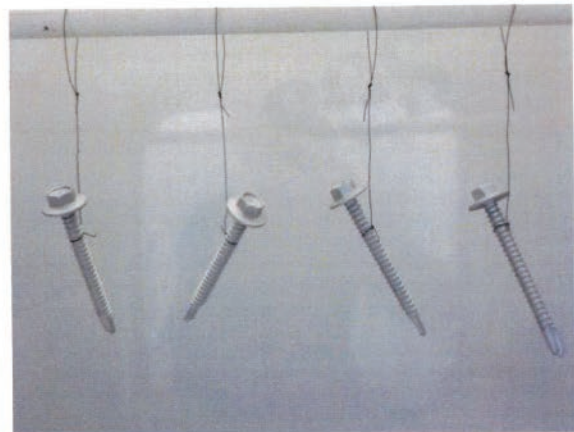
Fig. 2 : Method of Supporting specimens

Test Equipment		ERICHSEN 519/SA	
SO ₂ Concentration		2.0 L (0.67%) / Cycle	
Method of Supporting specimens		As show in Fig. 2	
Test Cycle	1st test phase	Test Time	8 Hours
		Test Temp.	40°C±3°C
		Test Humidity	Approximately 100%
	2nd test phase	Test Times	16 Hours
		Test Temp.	18°C~28°C
		Test Humidity	75% max.

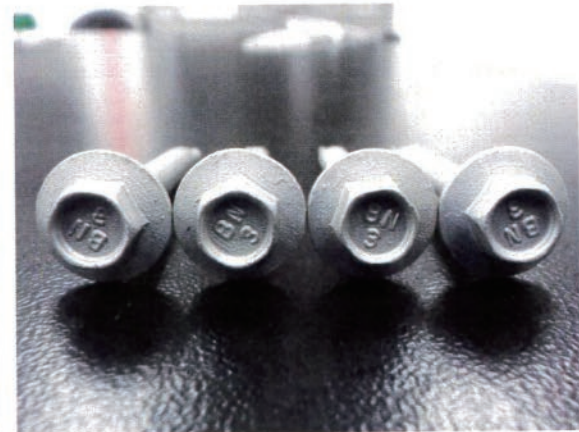
Fig. 4 : After test

No red rust was found on the head of all samples

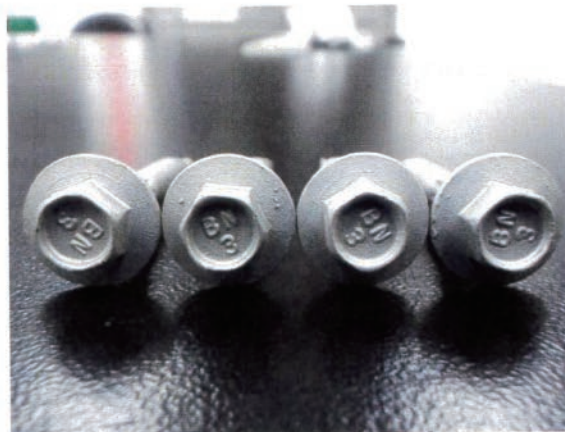
Fig. 4 : After test

No red rust was found on the head of all samples

Test Equipment		ERICHSEN 519/SA	
SO ₂ Concentration		2.0 L (0.67%) / Cycle	
Method of Supporting specimens		As show in Fig. 2	
Test Cycle	1st test phase	Test Time	8 Hours
		Test Temp.	40°C±3°C
		Test Humidity	Approximately 100%
	2nd test phase	Test Times	16 Hours
		Test Temp.	18°C~28°C
		Test Humidity	75% max.

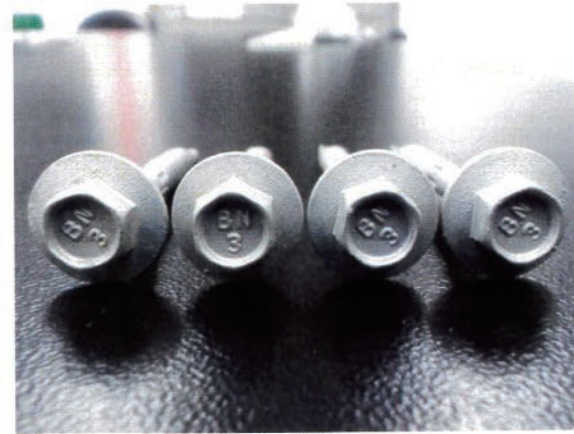
Fig. 4 : After test

No red rust was found on the head of all samples

Test Equipment		ERICHSEN 519/SA	
SO ₂ Concentration		2.0 L (0.67%) / Cycle	
Method of Supporting specimens		As show in Fig. 2	
Test Cycle	1st test phase	Test Time	8 Hours
		Test Temp.	40°C±3°C
		Test Humidity	Approximately 100%
	2nd test phase	Test Times	16 Hours
		Test Temp.	18°C~28°C
		Test Humidity	75% max.

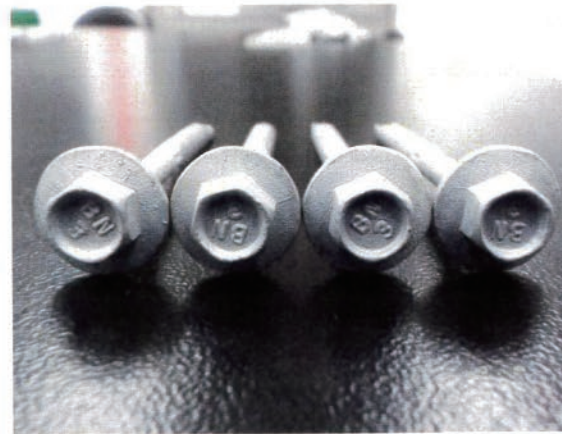
Fig. 4 : After test

No red rust was found on the head of all samples

Test Equipment		ERICHSEN 519/SA	
SO ₂ Concentration		2.0 L (0.67%) / Cycle	
Method of Supporting specimens		As show in Fig. 2	
Test Cycle	1st test phase	Test Time	8 Hours
		Test Temp.	40°C±3°C
		Test Humidity	Approximately 100%
	2nd test phase	Test Times	16 Hours
		Test Temp.	18°C~28°C
		Test Humidity	75% max.

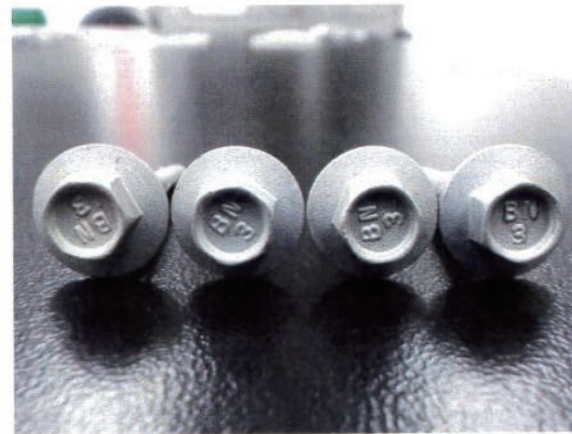
Fig. 4 : After test

No red rust was found on the head of all samples

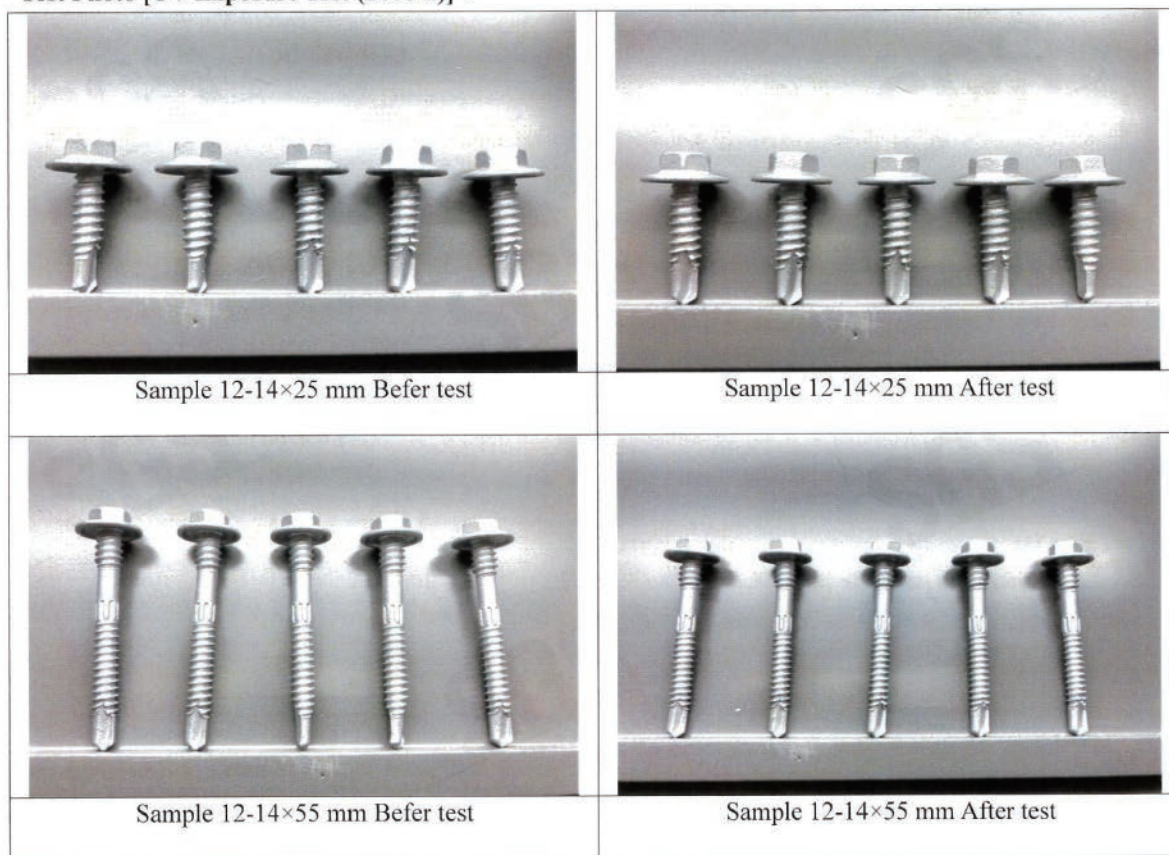
Test Photo [UV Exposure Test (2000 h)] :

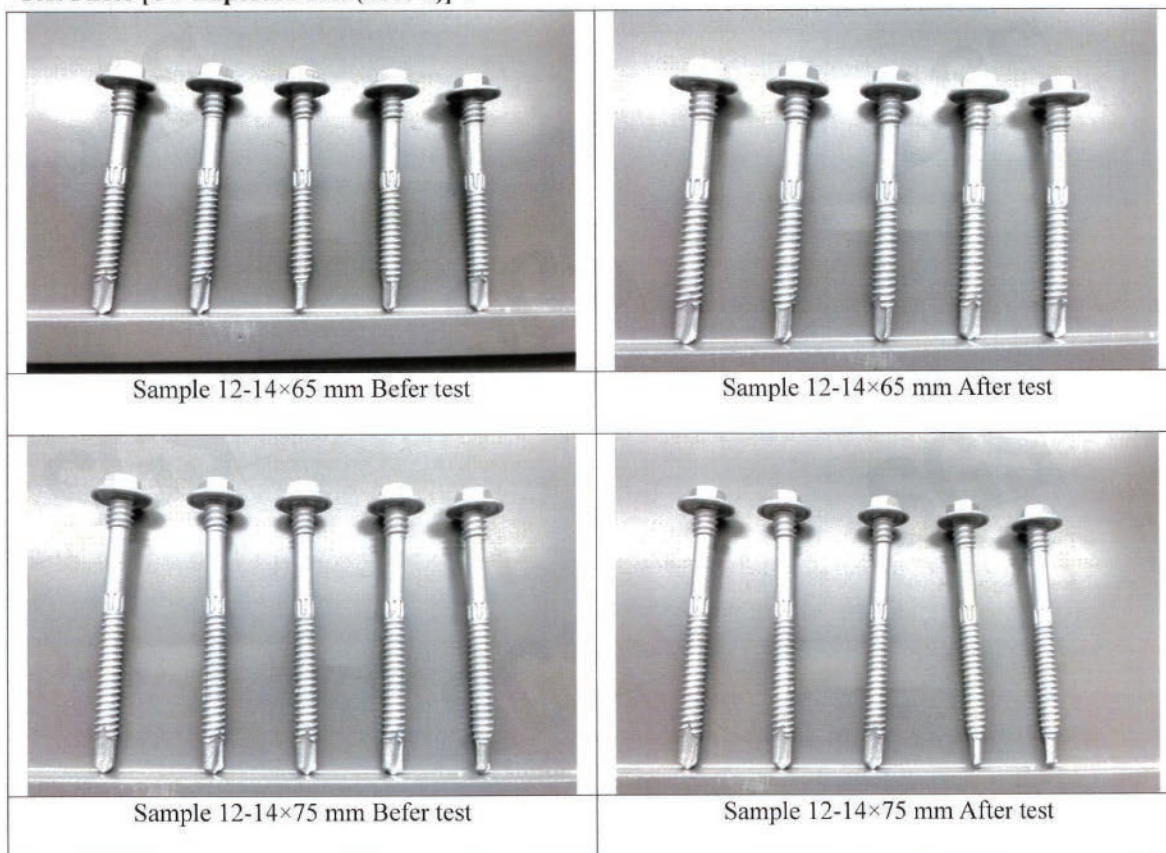
Test Photo [UV Exposure Test (2000 h)] :

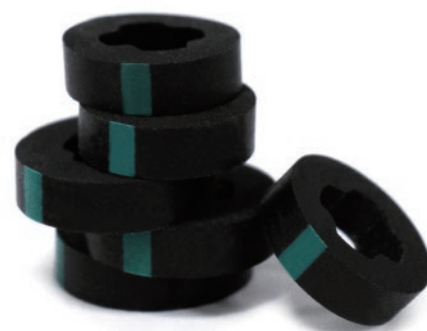
**Eco-BDN
Green Washer**

ASTM Method	Test Description	Specification	Result
D2240	Shore 'A' Hardness	80 +/- 5	82
D412	Tensile Strength (Mpa)	4.0 min	7.79
	Elongation (%)	150 min	410
D624	Tear Strength (kN/m)	20 min	33
D395	Compression set (%)	-	27
D573	Heat Resistance 70hrs @100°C	-	-
	Tensile Strength Change (%)	+/-10	+11
	Elongation Change (%)	+/-25	-22
	Hardness Change (Type A/1 sec)	+/-25	+4
D1171	Resistance to Ozone (100hrs@40°C)	-	100ppm No cracks
D2137	Low Temperature Brittleness (3min@-50°C)	-	Non-brittle
D257	Surface Resistivity (Ω)	-	Non-conductive
	Volume Resistivity(Ω-cm)	-	Non-conductive
